**SUMMER HOUSE in OLD PONTE VEDRA**  
**700 Ocean Place**  
**Ponte Vedra Beach, FL 32082**

## **NOTICE OF BOARD OF DIRECTOR'S MEETING**

**BOARD MEETING MINUTES  
June 3, 2024**

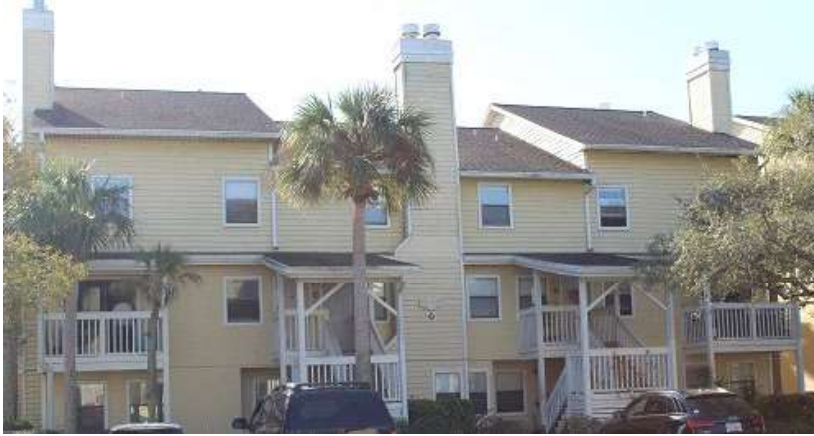
Typical foundation with no cracks

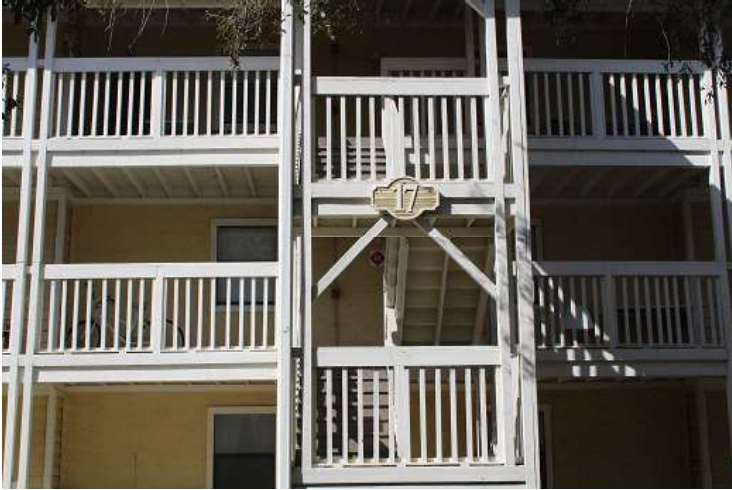
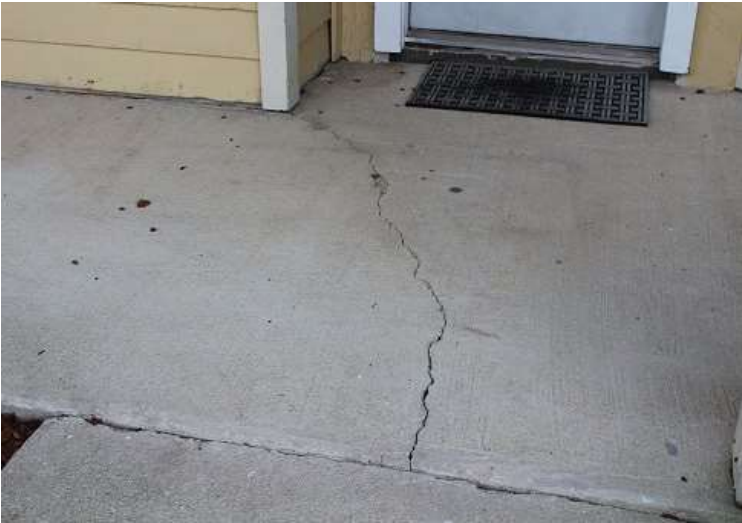
Typical sidewalk cracks near stairs

The areas noted are being addressed by the ongoing contract to replace exterior cladding and roofs.

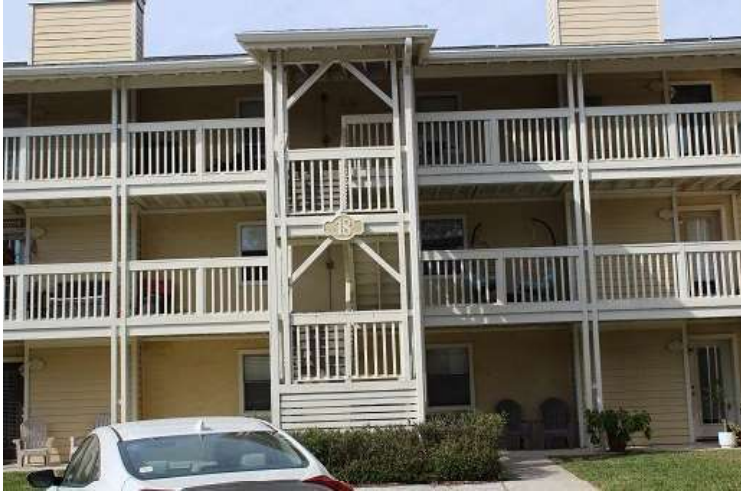
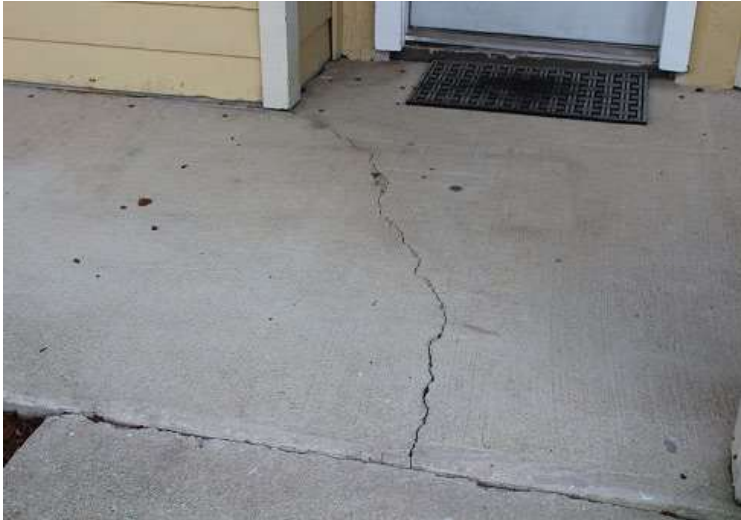
Typical sidewalk cracks near stairs

The areas noted are being addressed by the on going contract to replace exterior cladding and roofs.

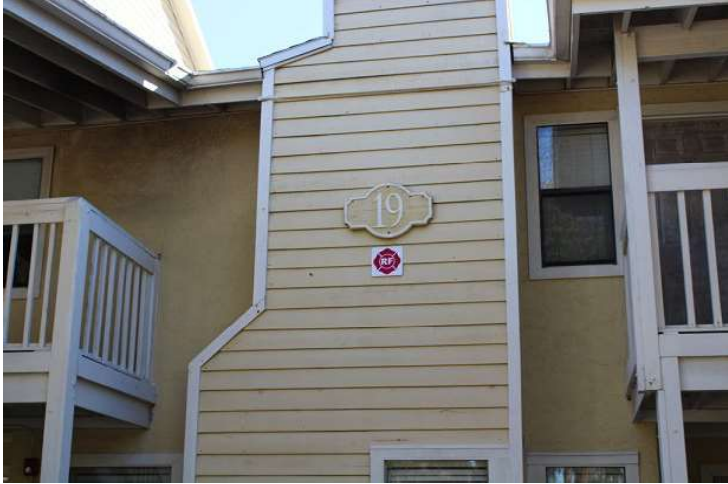
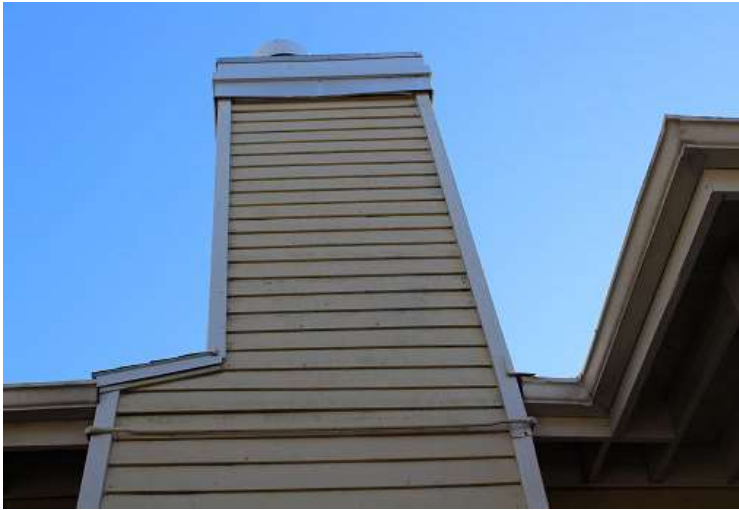
Chimney chase leaning

The areas noted are being addressed by the on going contract to replace exterior cladding and roofs.

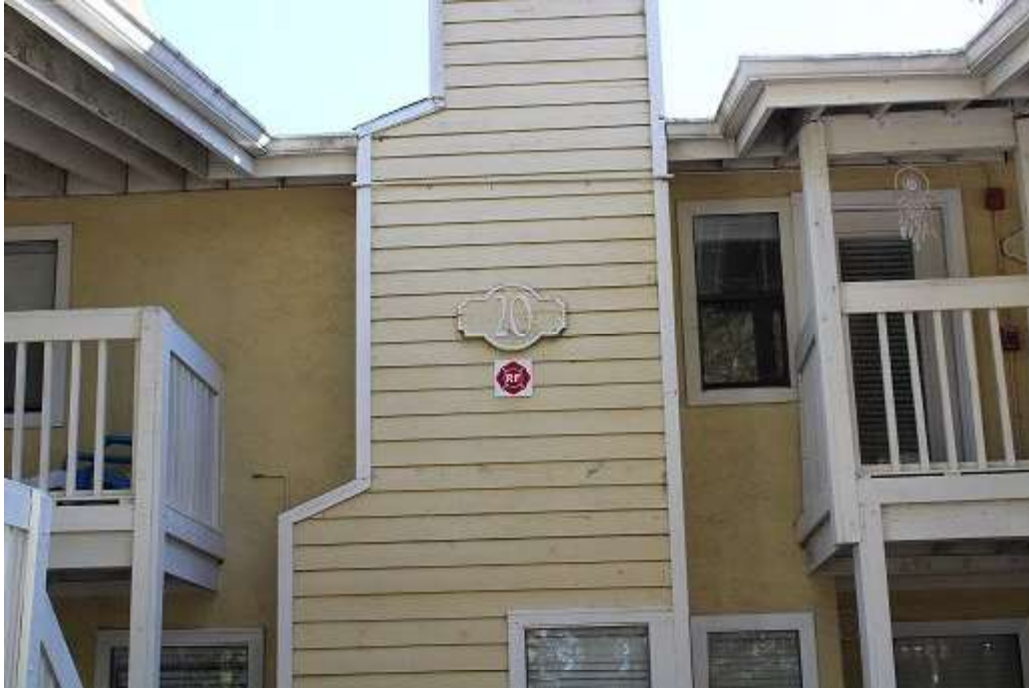
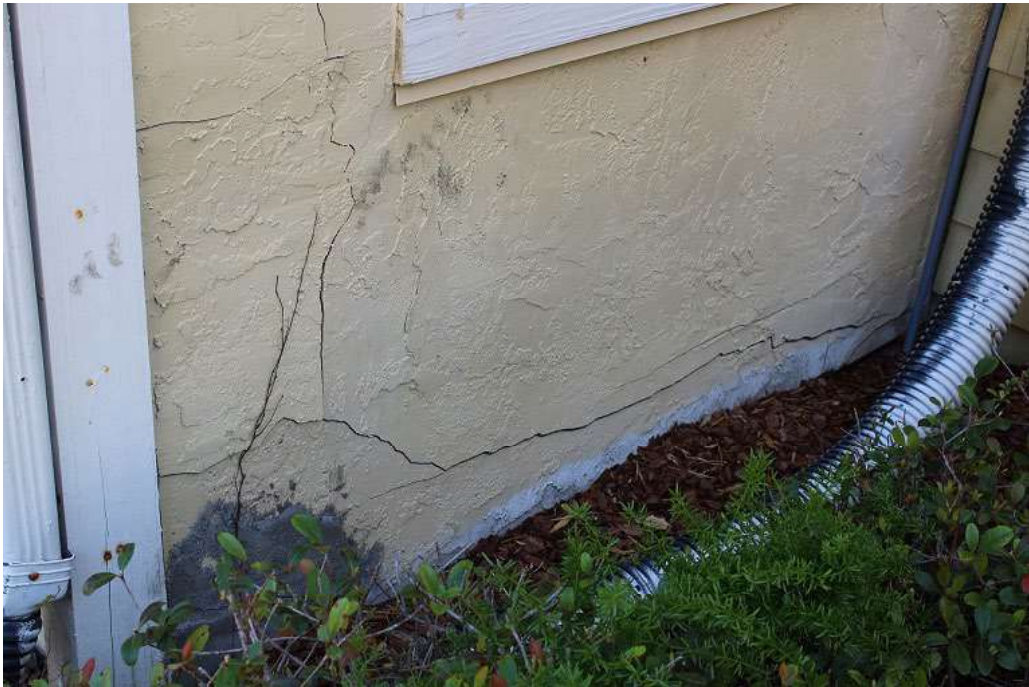
Stucco cracks next to west front chimney chase

The areas noted are being addressed by the on going contract to replace exterior cladding and roofs.

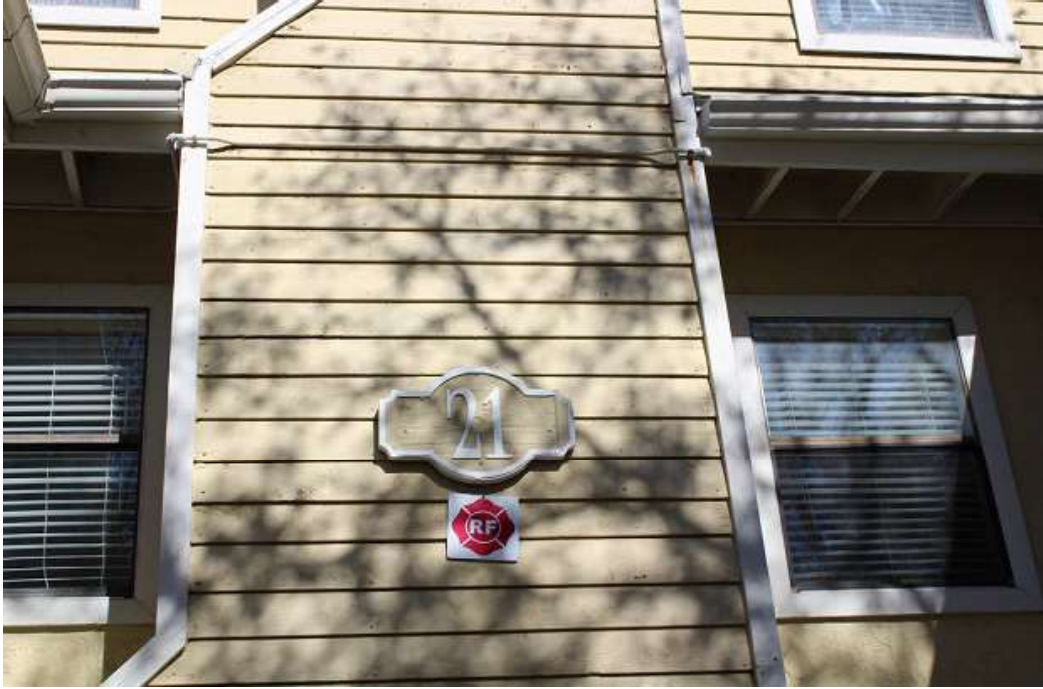
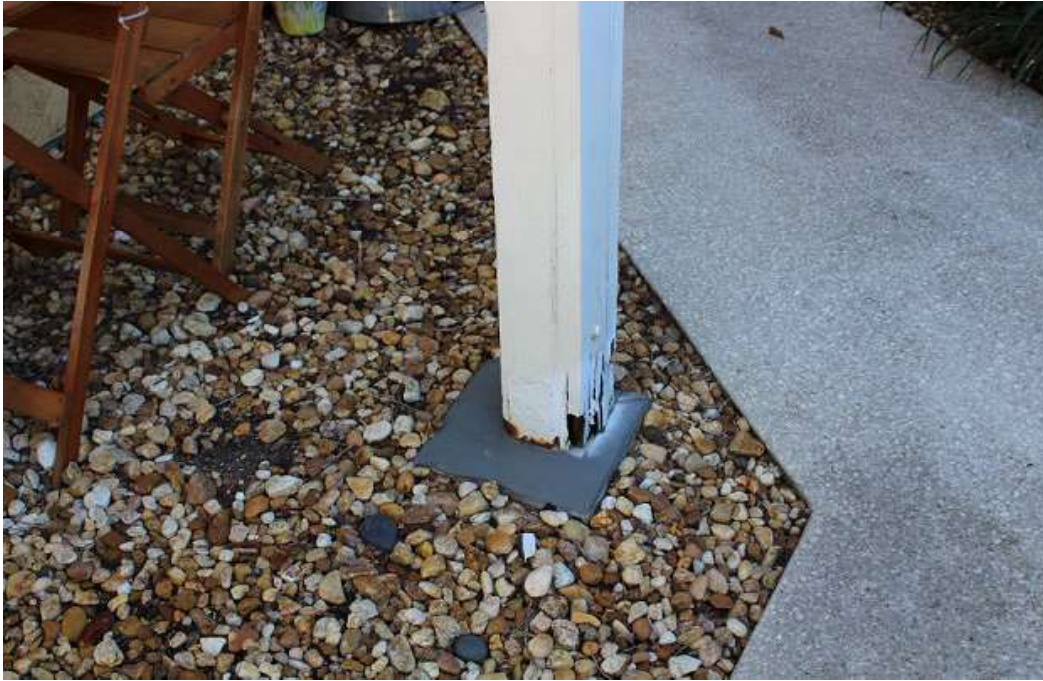
Rotten post base several locations

This building is structurally sound and has no signs of structural failure. The areas noted are being addressed by the on going contract to replace exterior cladding and roofs.

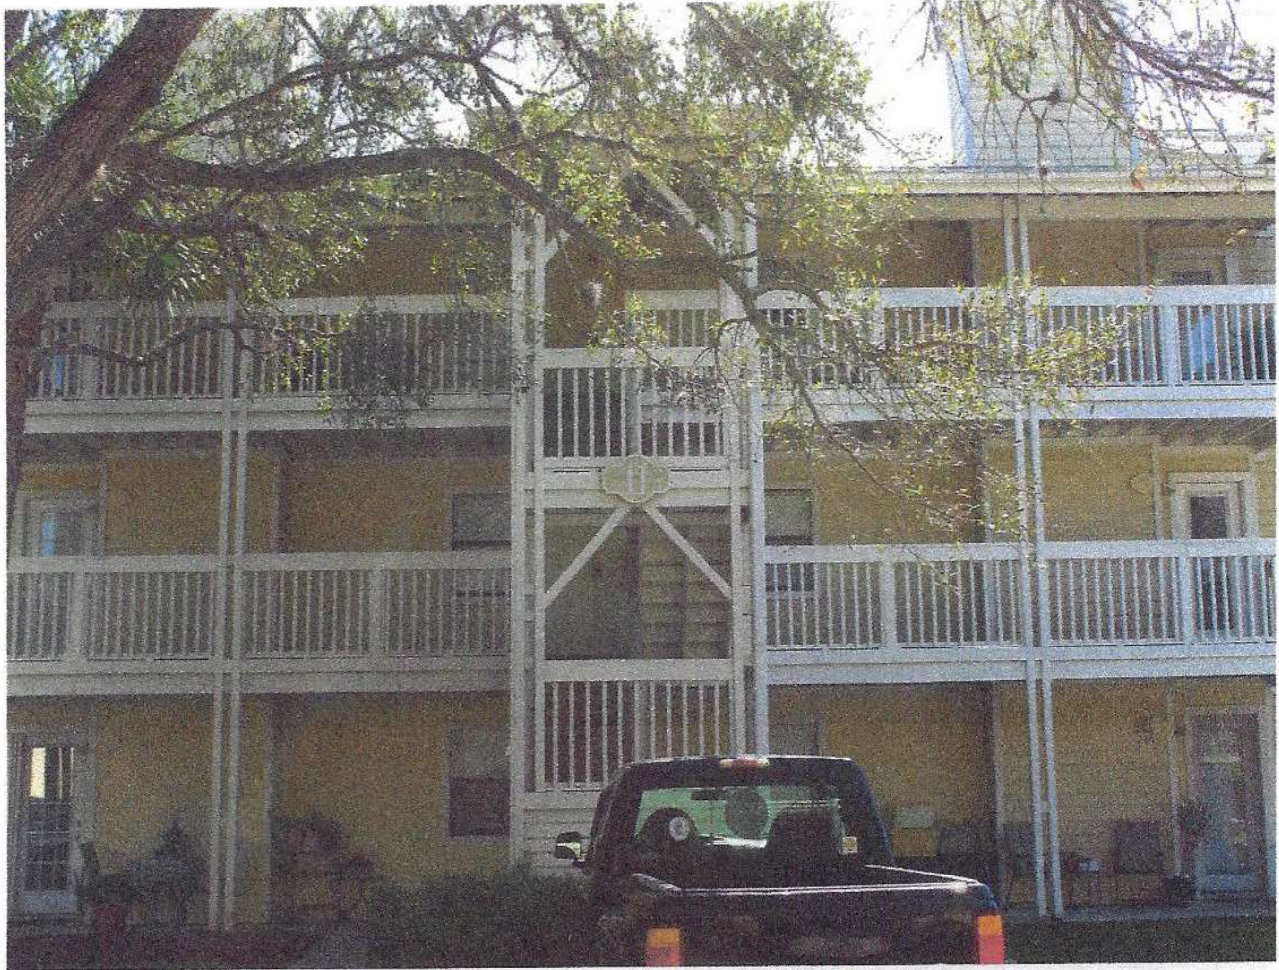
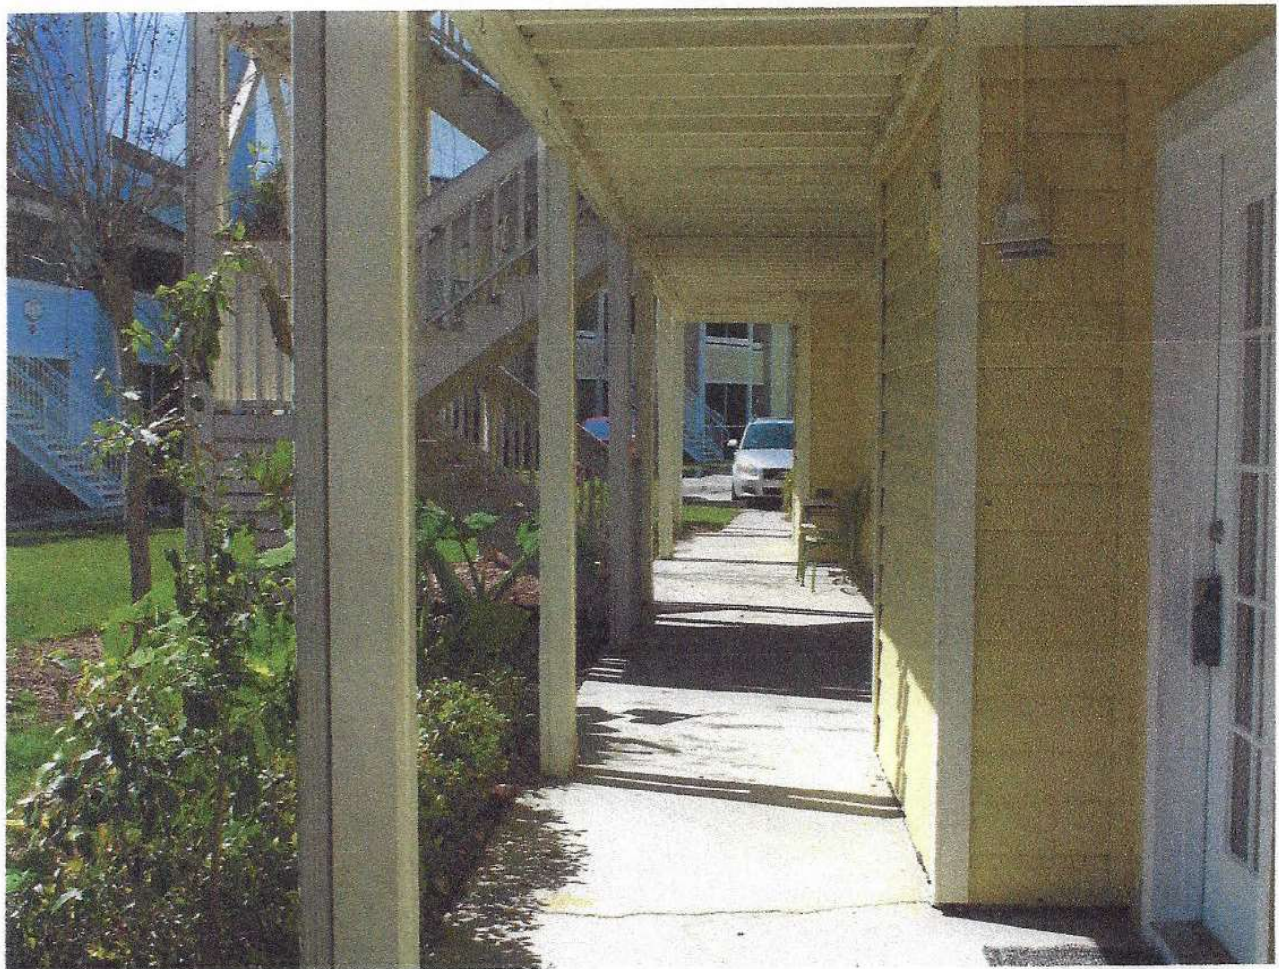
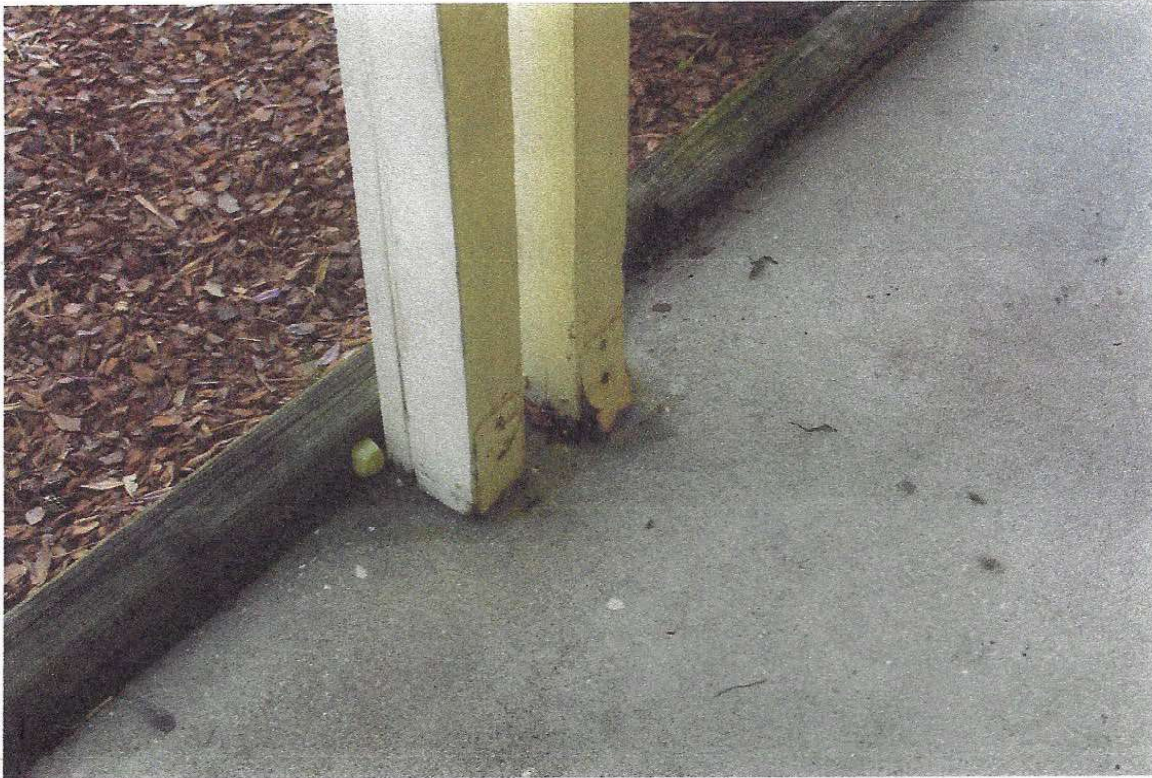
Posts on Front and Rear Porches Rotten Bases

This building is structurally sound; however, I recommend it be the next building repaired because of the need for new 4 x 4 posts and anchor bases.

The areas noted are being addressed by the on going contract to replace exterior cladding and roofs.

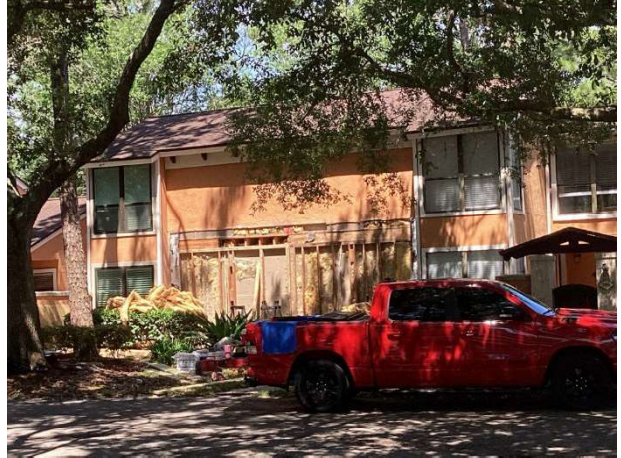
**Current stucco repairs**

**Useful Life:** We recommend inspections, repairs and paint finish applications every six- to eight-years.

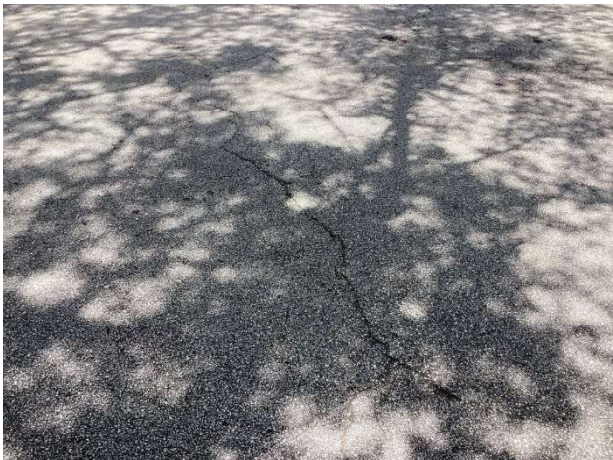
**Pavement cracks**

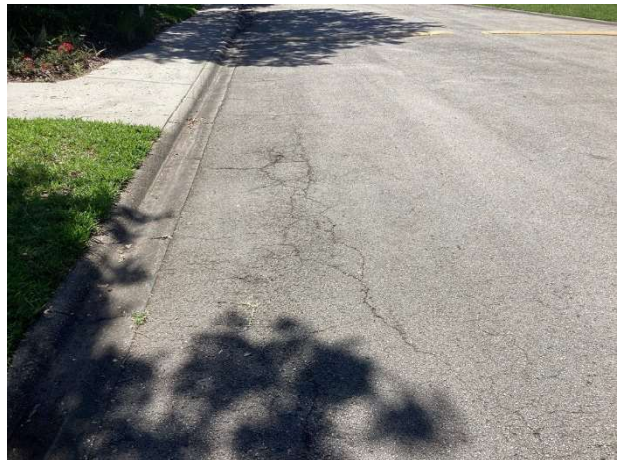
**Pavement cracks**

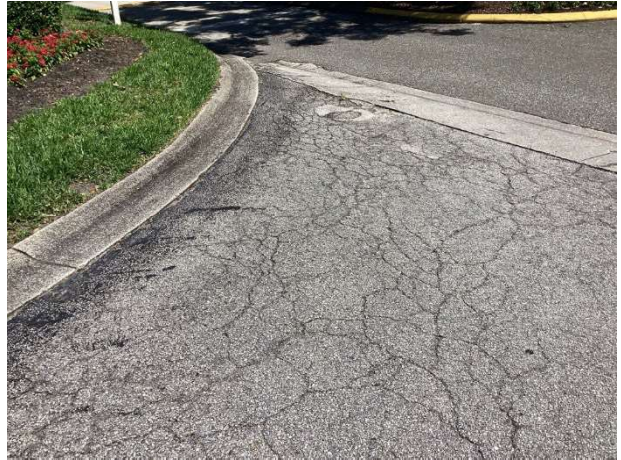
**Pavement cracks**

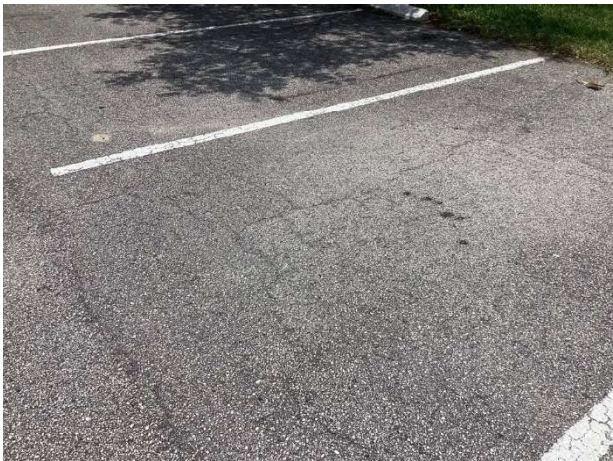
**Pavement cracks**

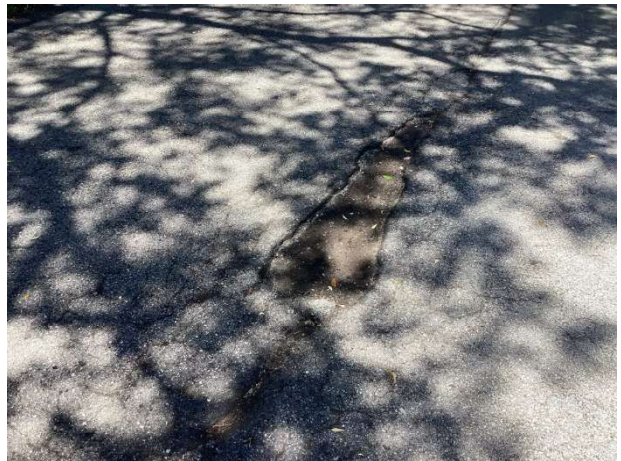
**Pavement pothole formation**

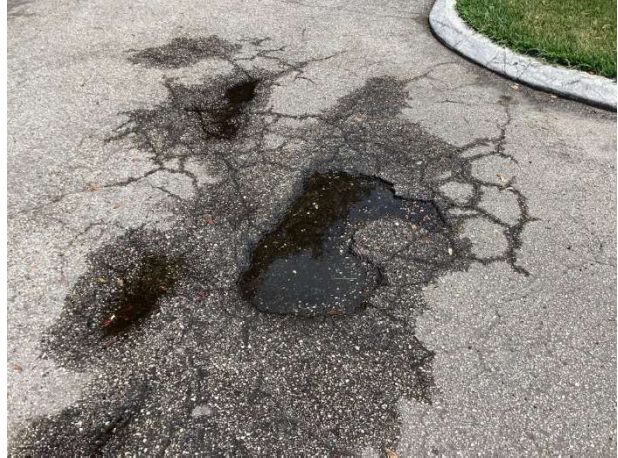
**Pavement pothole formation**

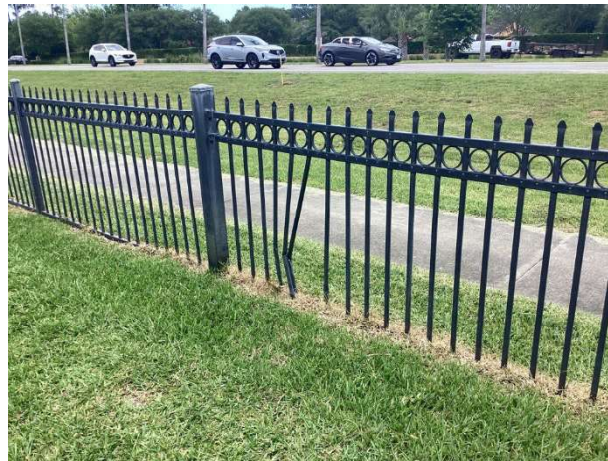
**Fence Damage**

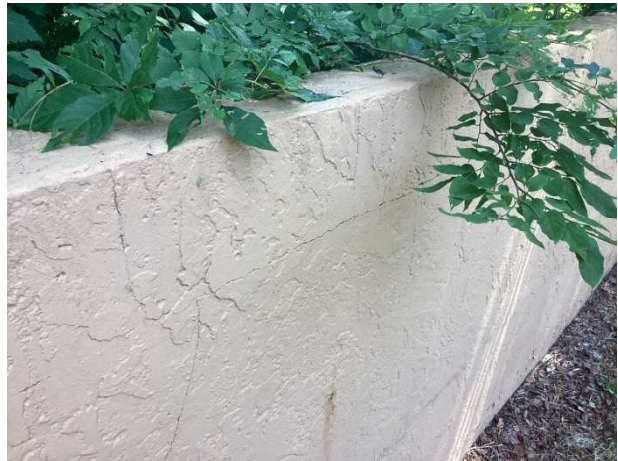
**Wall stucco cracks**

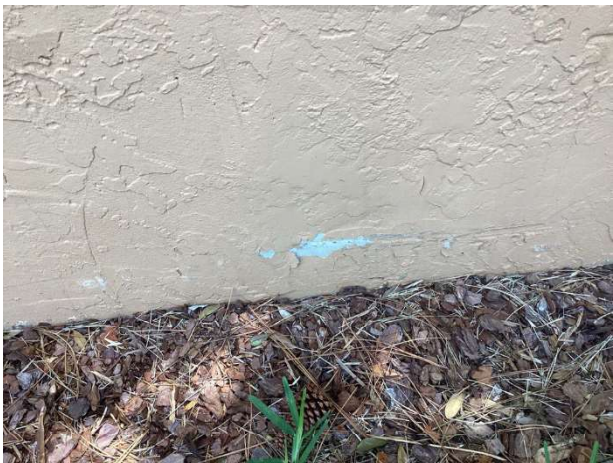
**Wall paint finish deterioration**

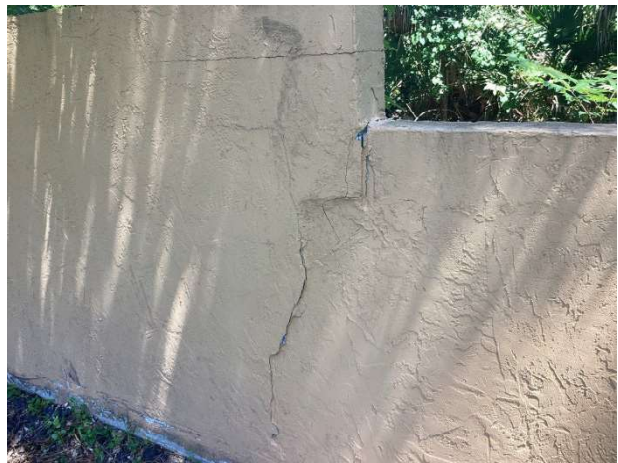
**Wall stucco cracks**

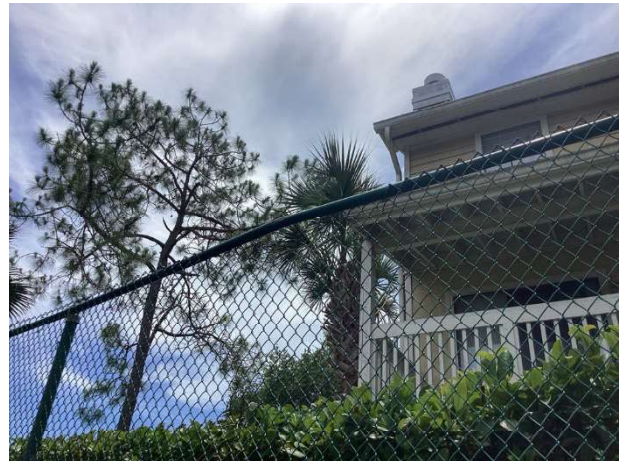
Fence damage

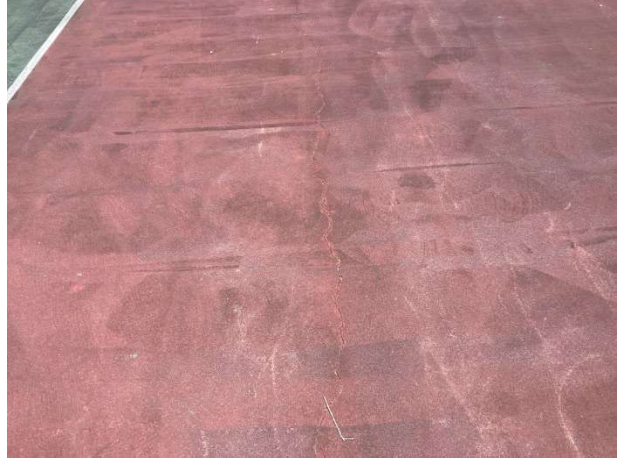
**Surface cracks**

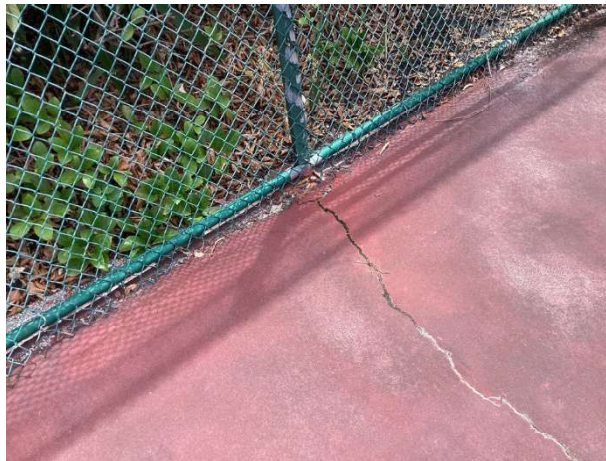
**Surface cracks**

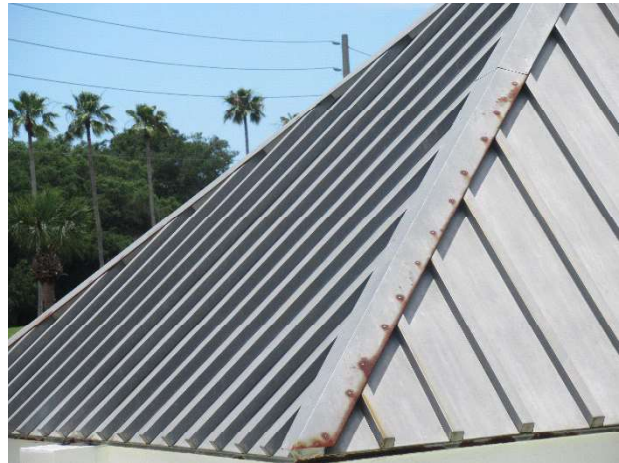
**Rust**

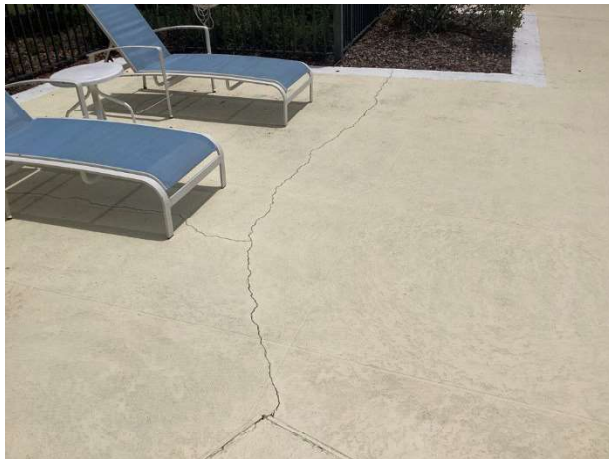
**Concrete cracks**

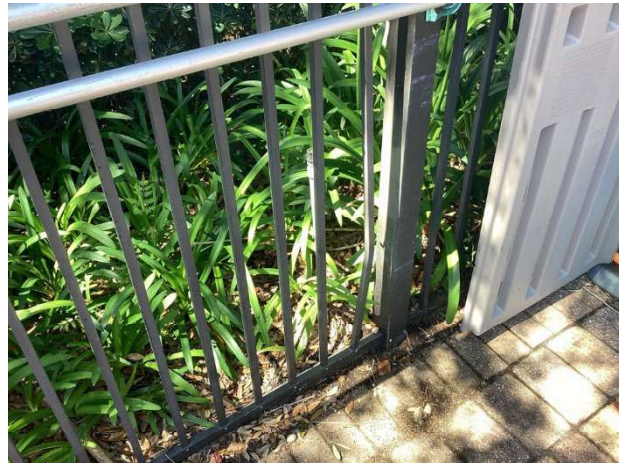
**Fence damage**
