**SUMMER HOUSE in OLD PONTE VEDRA**  
**700 Ocean Place**  
**Ponte Vedra Beach, FL 32082**

## **NOTICE OF BOARD OF DIRECTOR'S MEETING**

**BOARD MEETING MINUTES  
June 3, 2024**

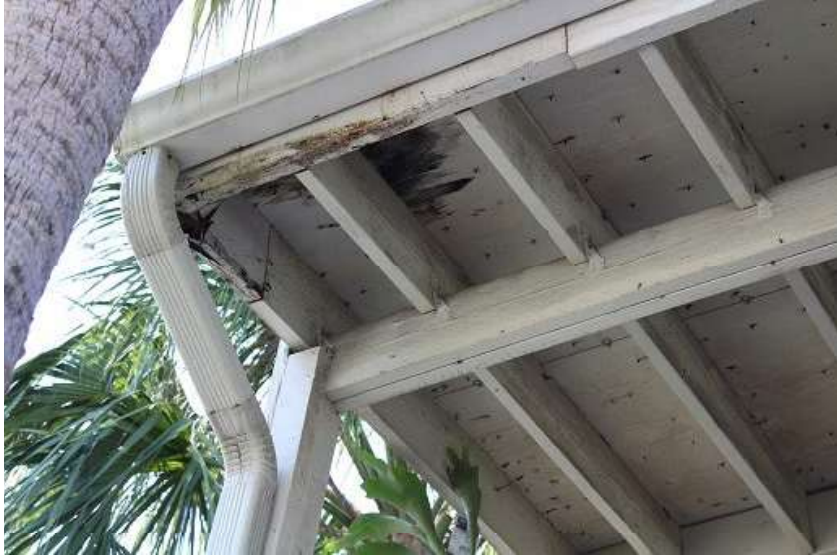
Rotten fascia throughout structure

The areas noted are being addressed by the on going contract to replace exterior cladding and roofs.

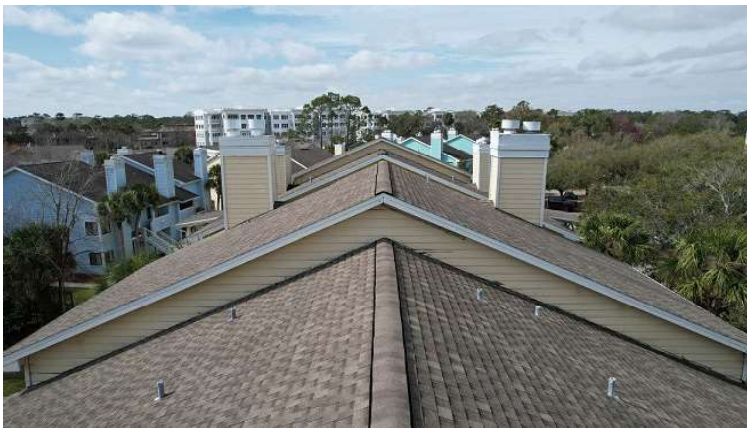
Chimney chase leaning

The areas noted are being addressed by the on going contract to replace exterior cladding and roofs.

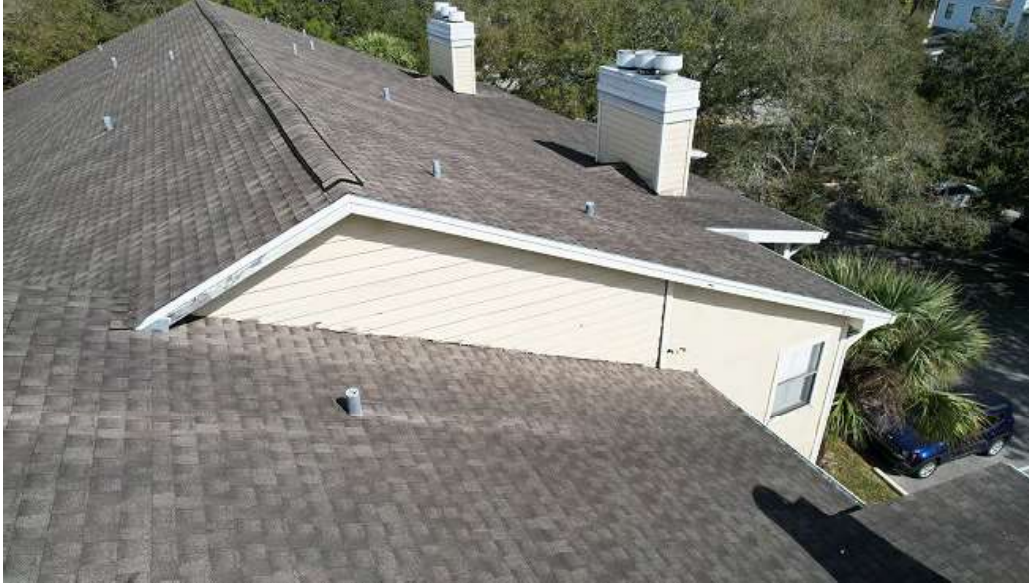
- Stucco cracks                                    X              Walls painted elastomeric paint. Near chimney chases.
- Siding nail pops                                X              Gable ends siding need re-nailing
- Window openings                              X              No
- Door openings                                    X              No

Stucco cracks next to west front chimney chase

The areas noted are being addressed by the on going contract to replace exterior cladding and roofs.

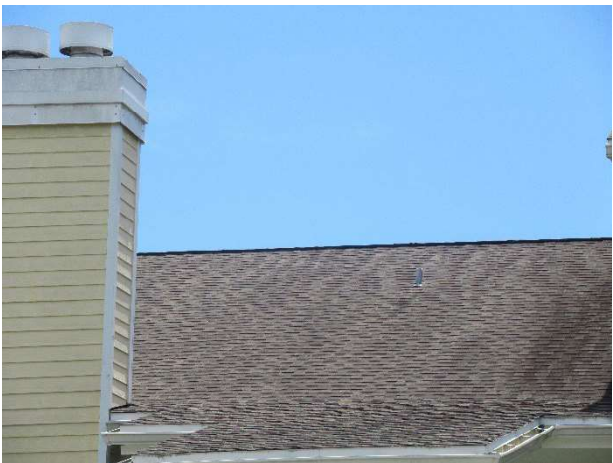
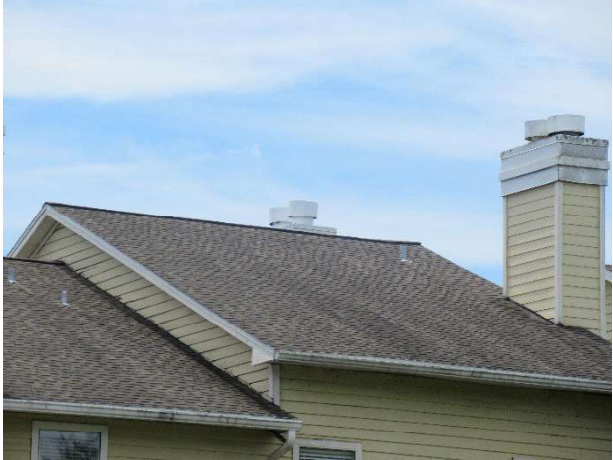
**Condition:** Good to fair overall with isolated weathered shingles evident. Management and the Board do not report a history of leaks.

**Weathered shingles at Golfside buildings**

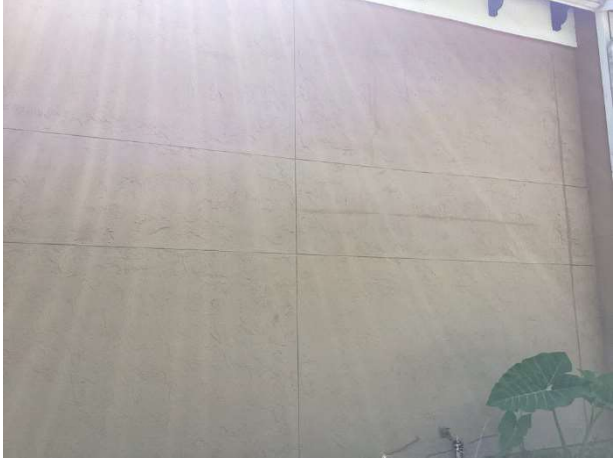
**Stucco wall finishes**

- Complete inspection of the stucco
- Crack repairs as needed (Each paint product has the limited ability to cover and seal cracks but we recommend repair of all cracks which exceed the ability of the paint product to bridge.)
- Replacement of up to one percent (1%), of the stucco walls (The exact amount of area in need of replacement will be discretionary based on the actual future conditions and the desired appearance.)
- Replacement of up to thirty-three percent (33%) of the sealants in coordination with each paint finish application.

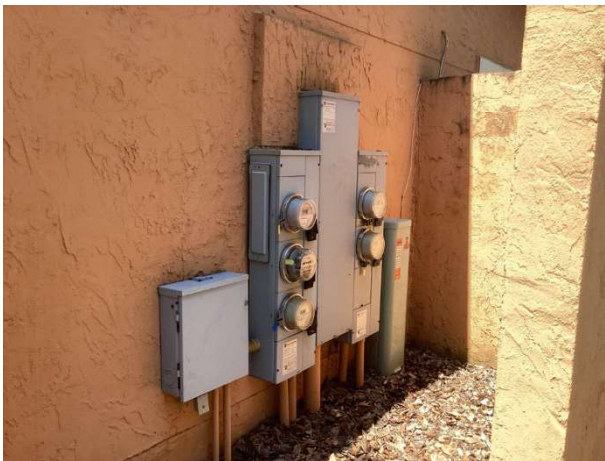
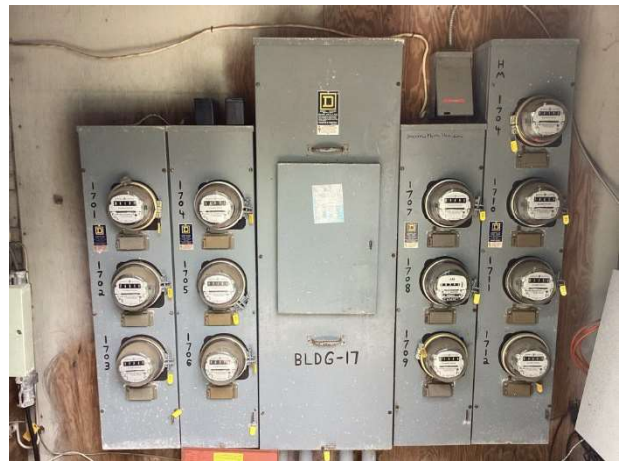
**Condition:** Reported satisfactory without operational deficiencies.

Electrical system main panels

We recommend the Association conduct thermoscans of the distribution panels and circuit protection panels, and inspections of the transformers for any indications of arcing, burning or overheating on a regular basis, funded through the operating budget.

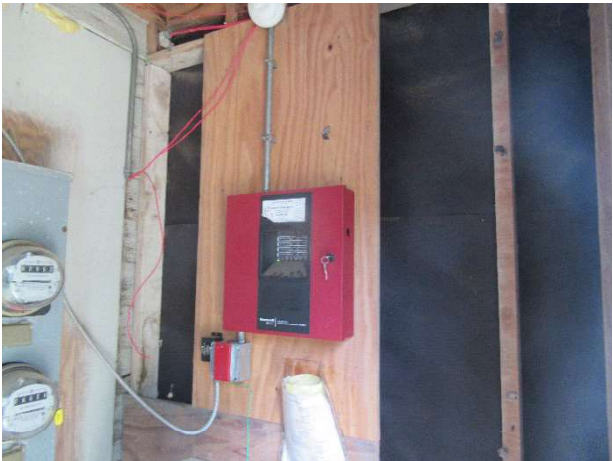
**Conditions:** Reported satisfactory without operational deficiencies.

**Control panel**

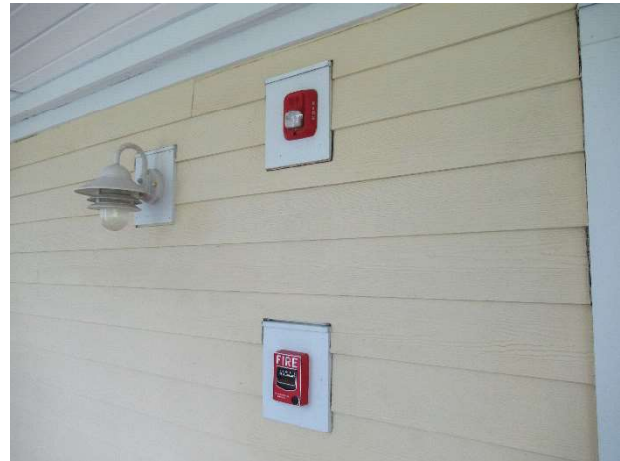
**Emergency devices**

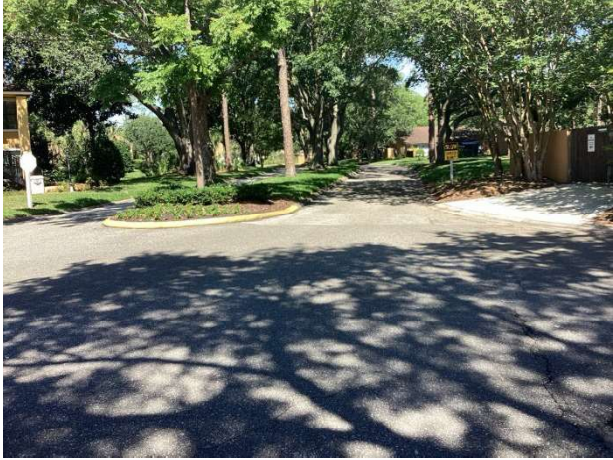
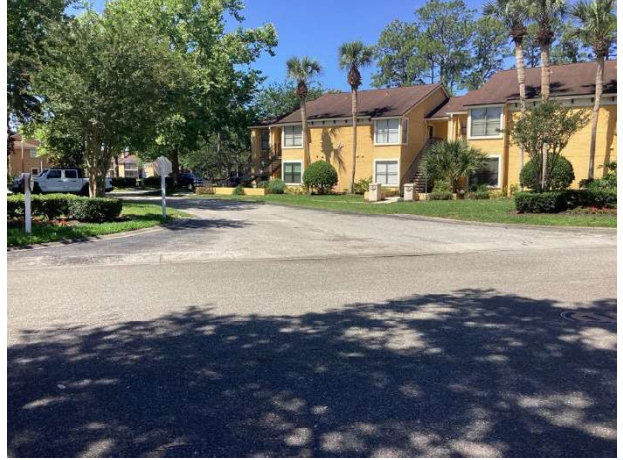
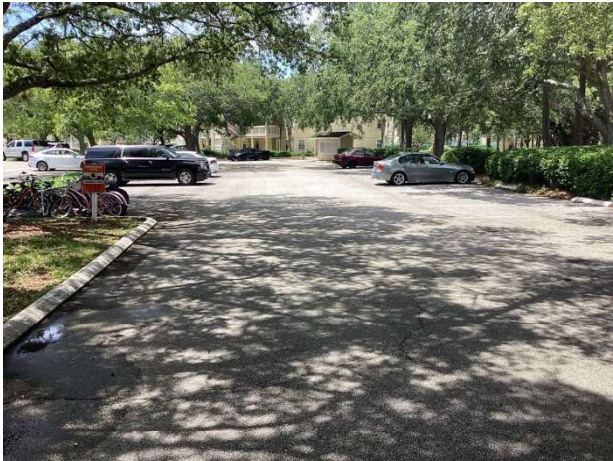
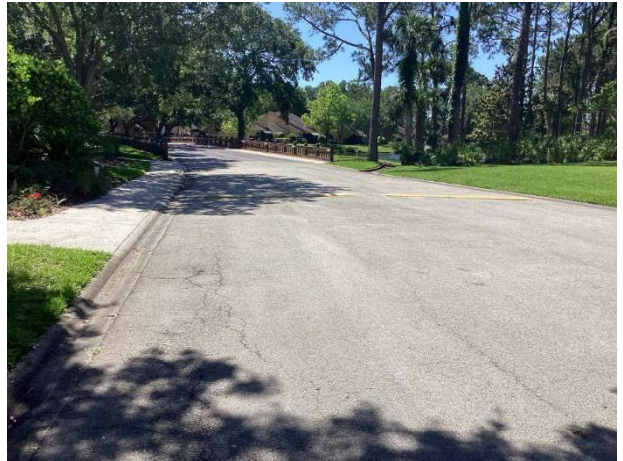
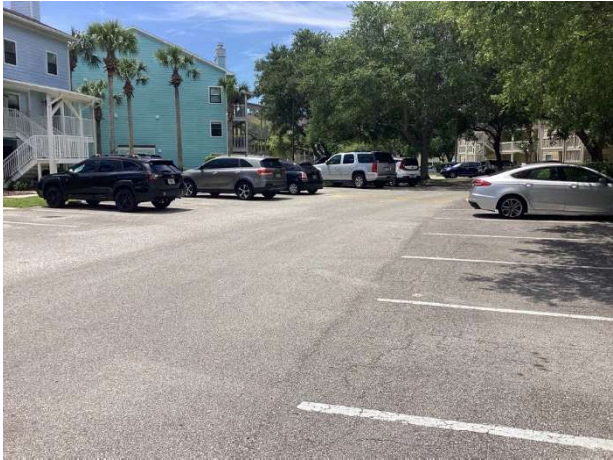
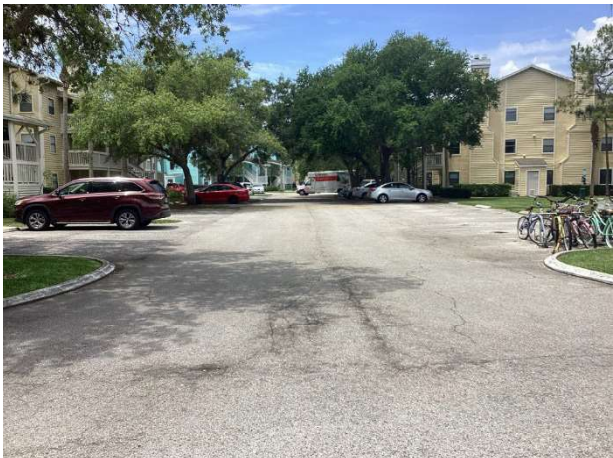
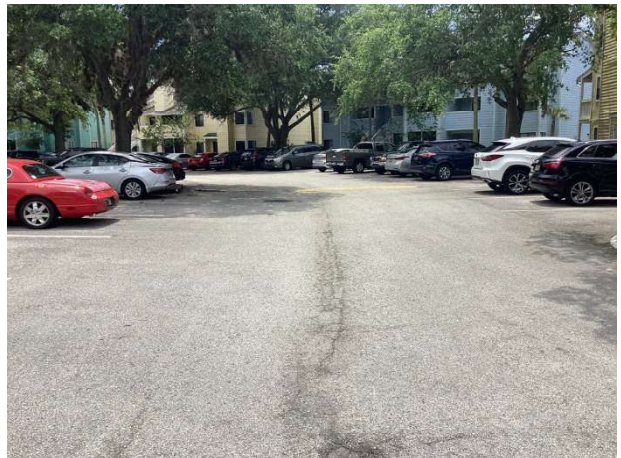
**Condition:** Fair overall with isolated cracks and potholes evident.

**Pavement overview**

- Repaving: The age was unavailable at the time of our inspection.
- Repairs: The age was unavailable at the time of our inspection. We recommend the Association conduct near term patch repairs to prevent damage to vehicles from potholes

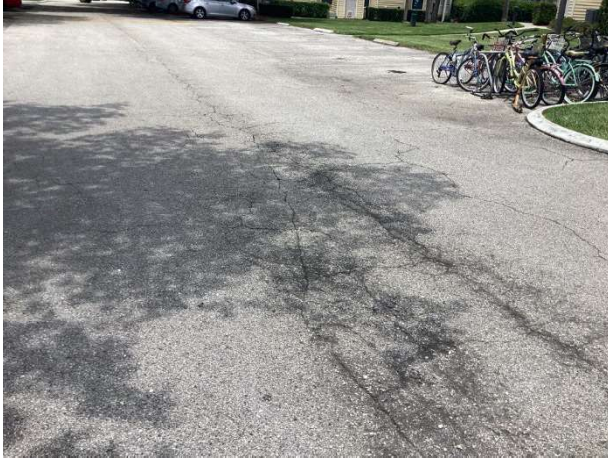
**Pavement cracks**

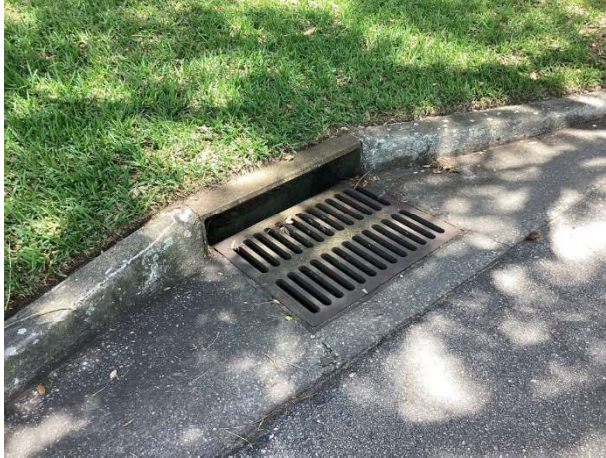
**Condition:** Good overall

**Catch basin**

**Expenditure Detail Notes:** Expenditure timing and costs are depicted in the **Reserve Expenditures** table in Section 3. We recommend the Association plan for inspections and capital repairs to the catch basins in conjunction with repaving.

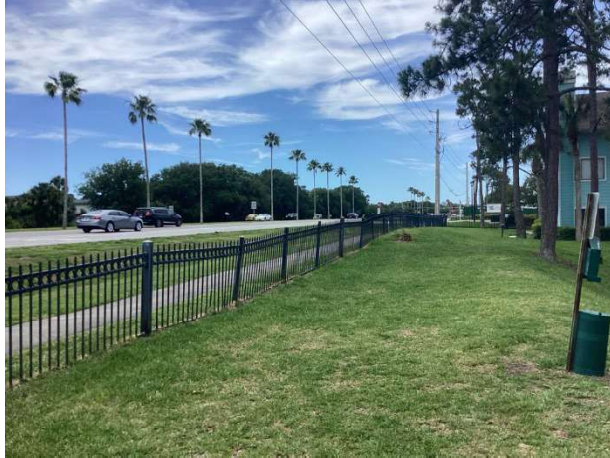
**Condition:** Good to fair overall with isolated fence lean and damage evident.

**Aluminum fence**

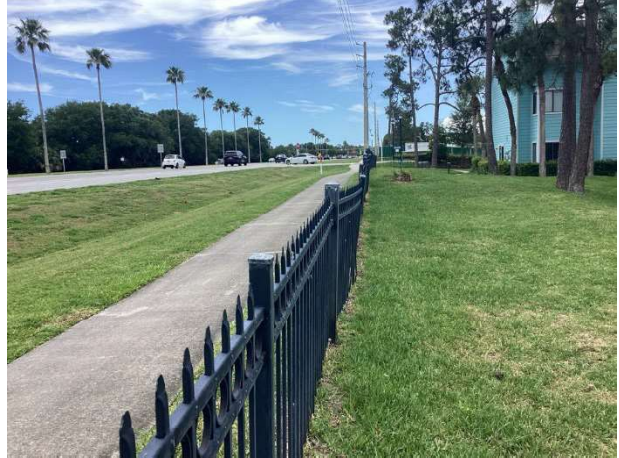
**Fence leaning section**

- Annually:
  - Inspect and repair loose fasteners or sections, and damage
  - Repair leaning sections and clear vegetation from fence areas which could cause damage

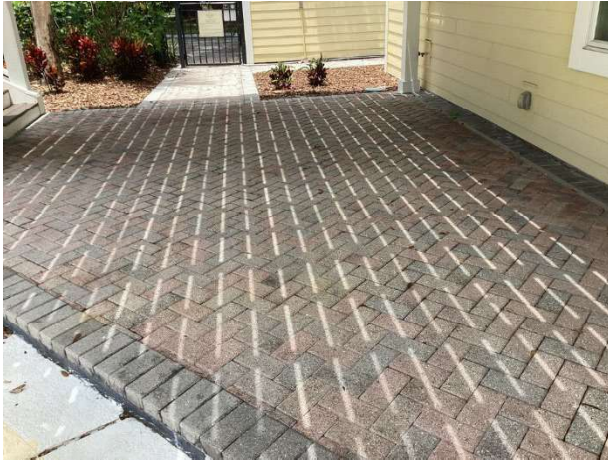
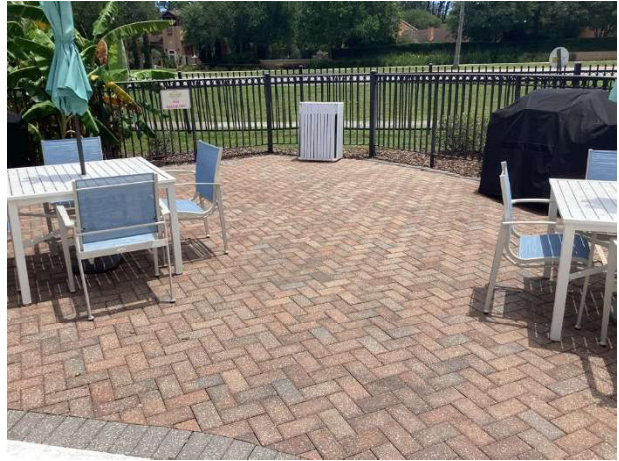
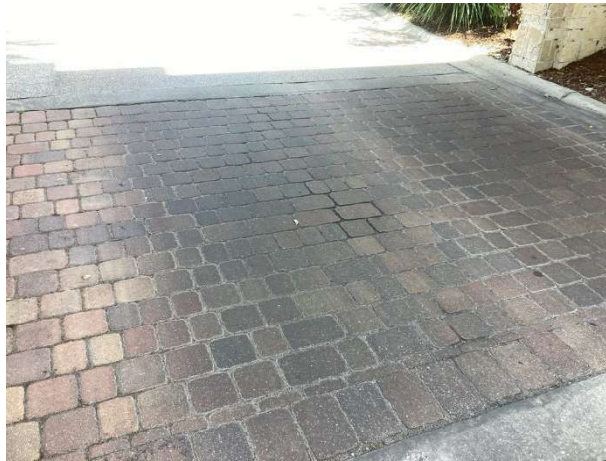
**Condition:** Good overall

**Masonry pavers overview**

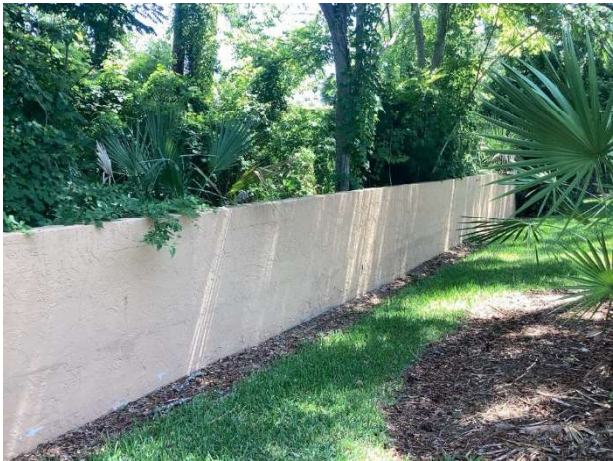
**Condition:** The walls are in satisfactory condition overall and paint finish is in satisfactory condition overall with isolated cracks evident.

**Stucco perimeter wall overview**

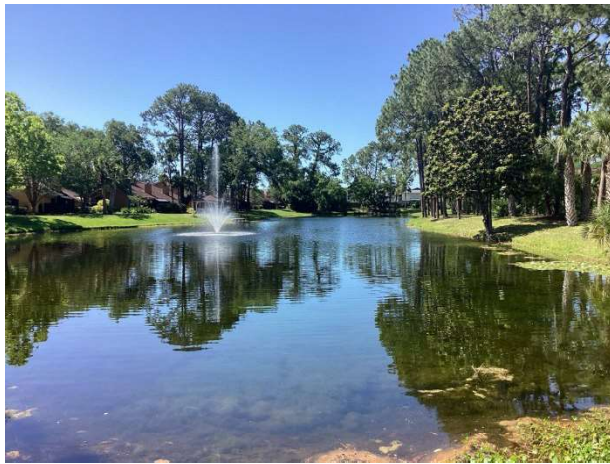
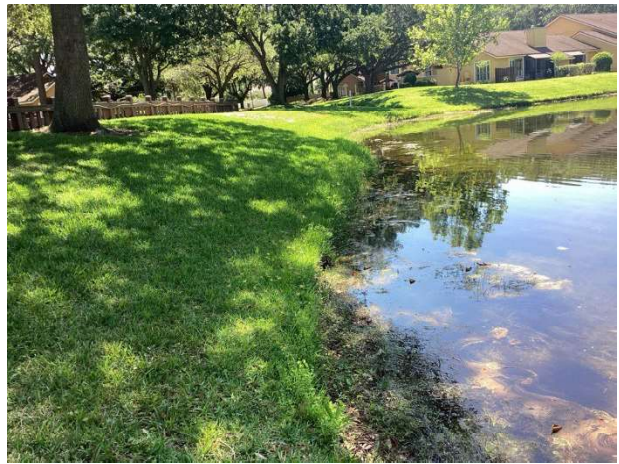
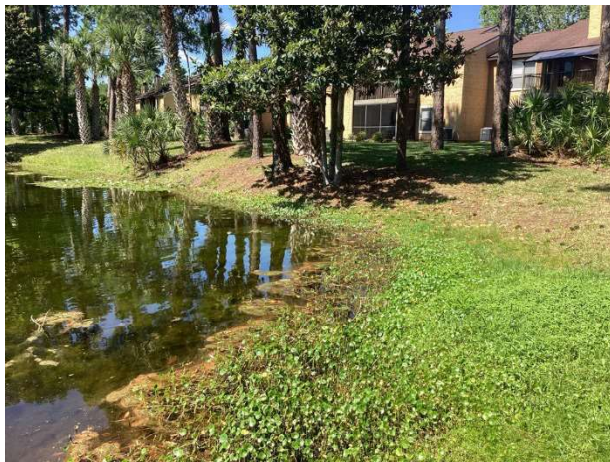
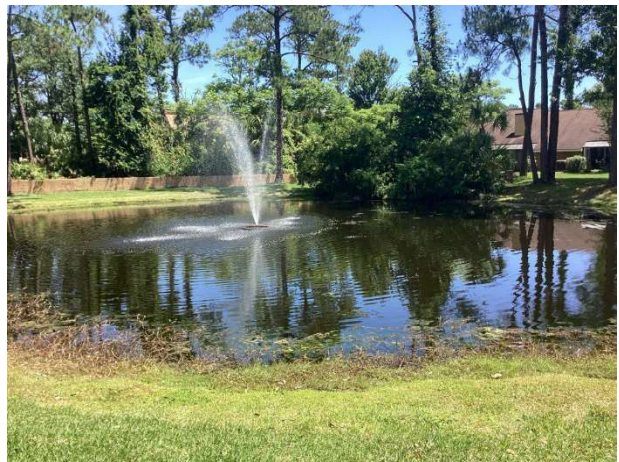
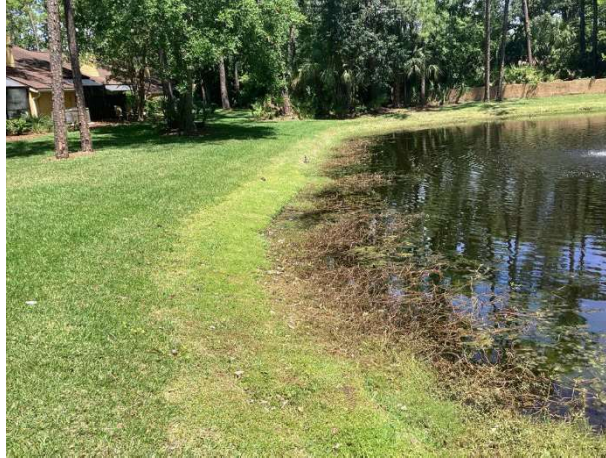
**Condition:** Good overall

**Pond overview**

**Pond shoreline**

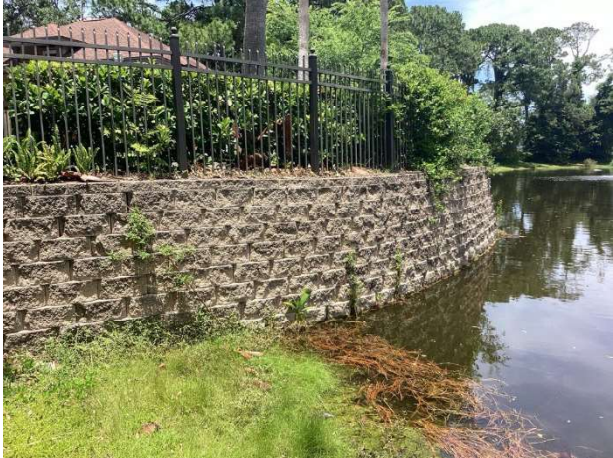
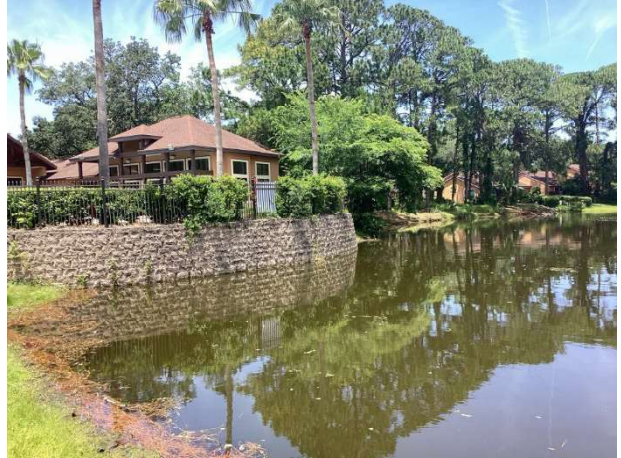
**Condition:** Good overall

Masonry retaining wall

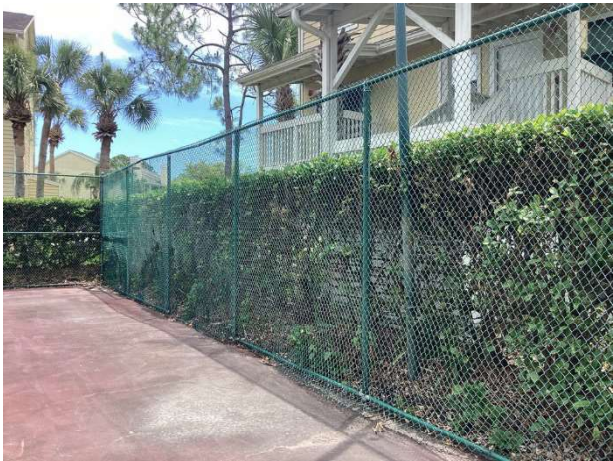
**Condition:** Good to fair overall with damage evident.

Chain link fence

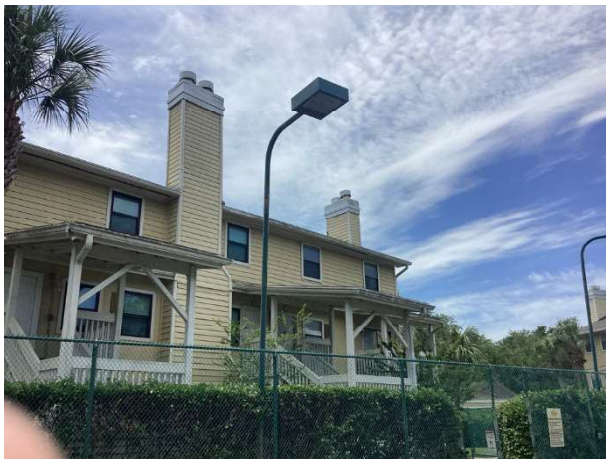
**Condition:** Good overall

**Light pole and fixture**

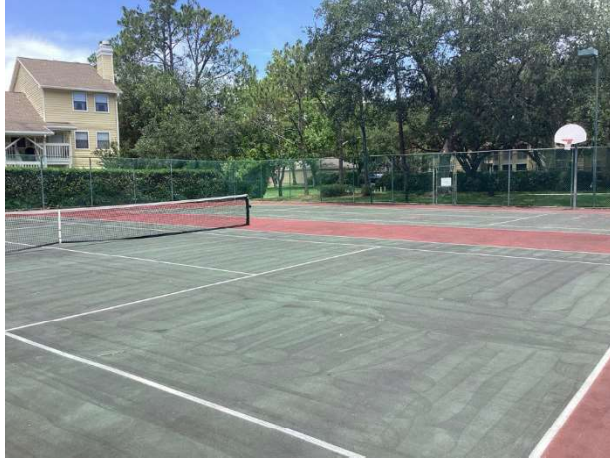
**Condition:** Fair overall with cracks and color coat fade evident.

**Tennis court overview**

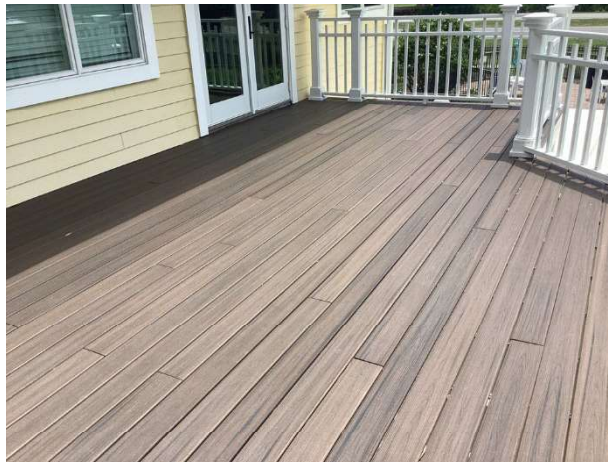
**Condition:** Good overall

**Golfside clubhouse balcony**

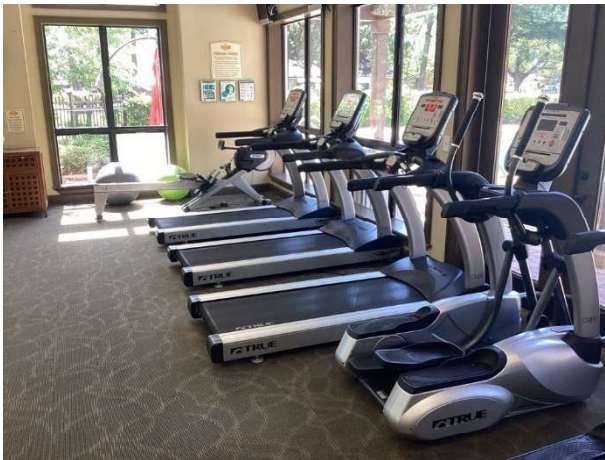
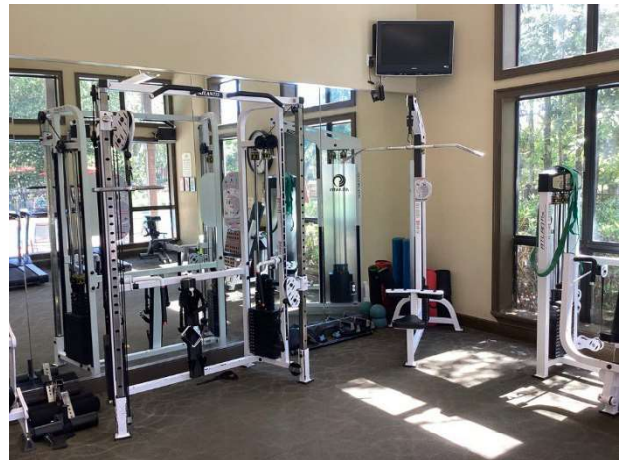
**Conditions:** Good overall

**Cardiovascular exercise equipment**

**Strength training exercise equipment**

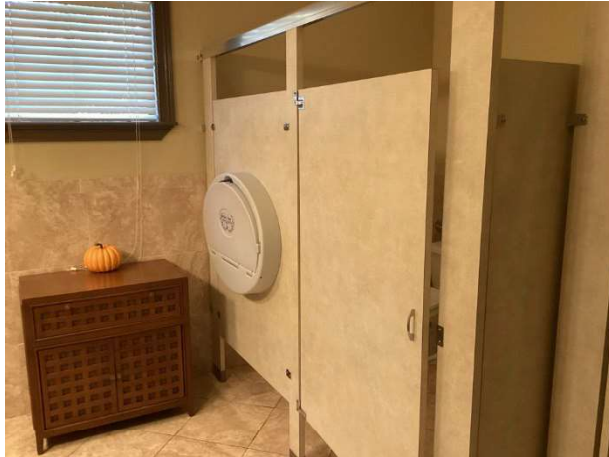
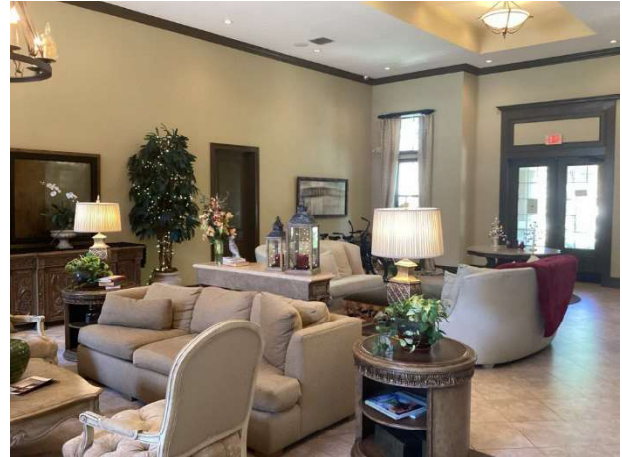
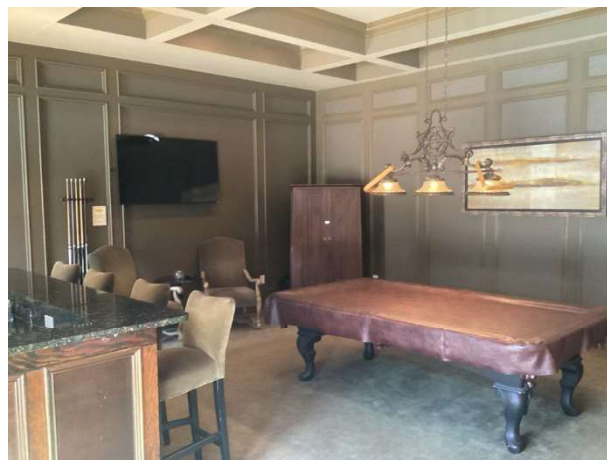
**Condition:** Good overall

**Clubhouse rest room**

**Clubhouse interior**

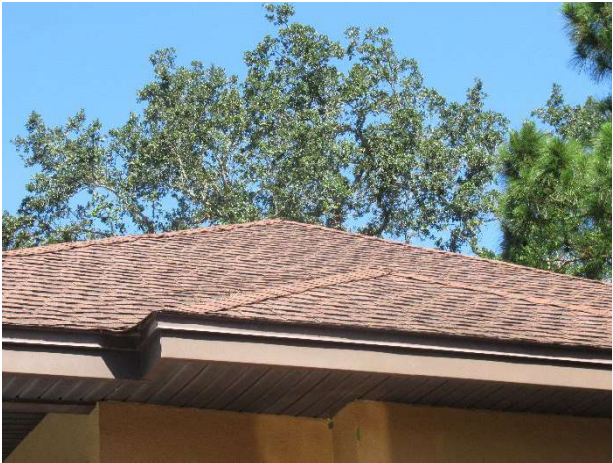
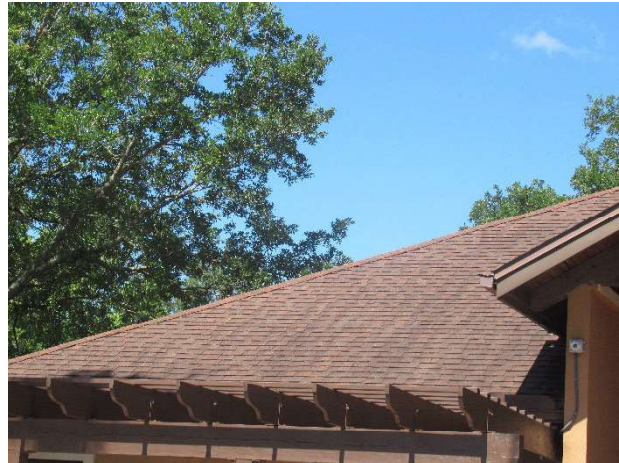
**Condition:** Good overall with no significant deterioration evident from our visual inspection from the ground. Management and the Board do not report a history of leaks.

Beachside clubhouse roof

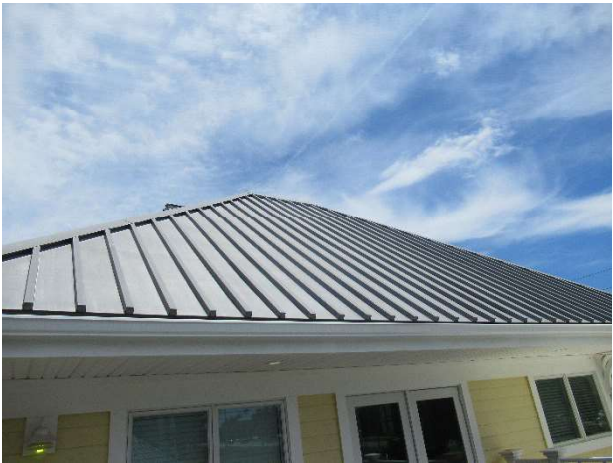
**Condition:** Good to fair overall with isolated rust evident. Management and the Board do not report a history of leaks.

**Metal roof at Golfside clubhouse**

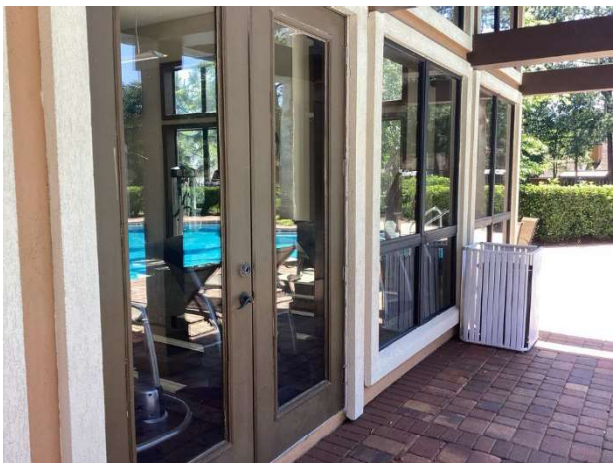
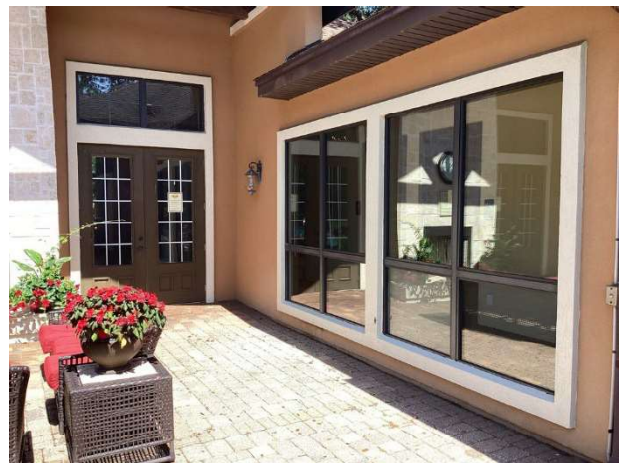
**Condition:** Good overall

Common windows and doors

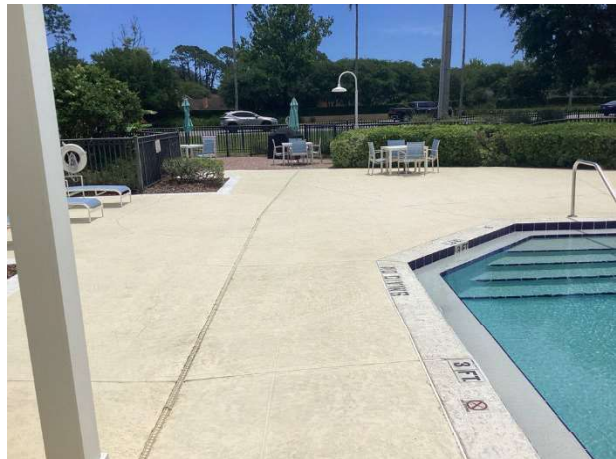
**Condition:** Good to fair overall with isolated concrete cracks evident

**Golfside concrete pool deck**

- Selective cut out and replacements of up to ten percent (10%) of concrete
- Crack repairs as needed
- Mortar joint repairs
- Caulk replacement
- Coating replacement

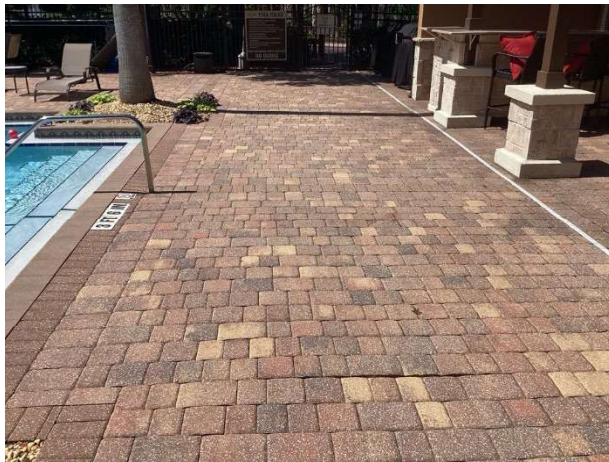
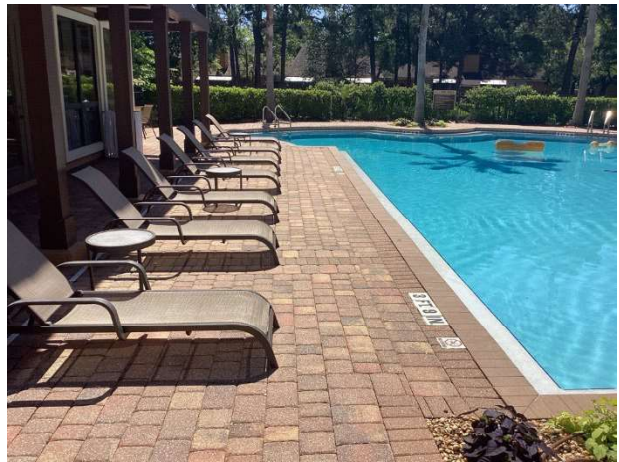
**Condition:** Good to fair overall with isolated dislodged pavers evident

**Paver pool deck overview**

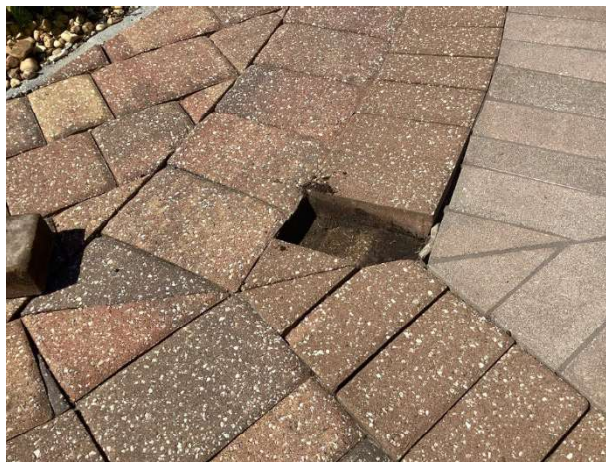
**Dislodged pavers**

- Annually:
  - Inspect and repair settlement, trip hazards and significant paver spall
  - Reset and/or reseal damaged pavers as necessary
  - Periodically clean and remove overgrown vegetation as needed

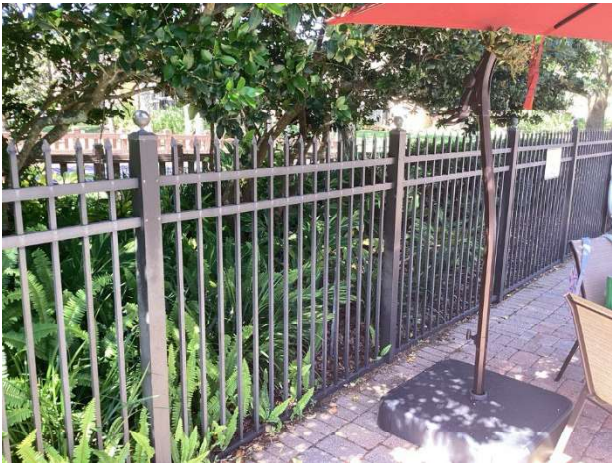
**Condition:** Good to fair overall with isolated damage evident.

**Aluminum pool fence**

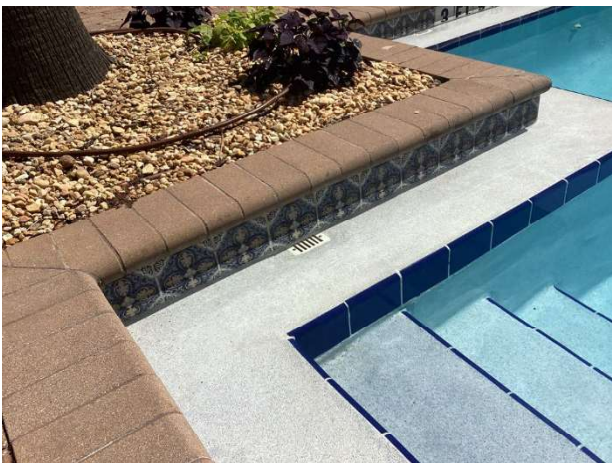
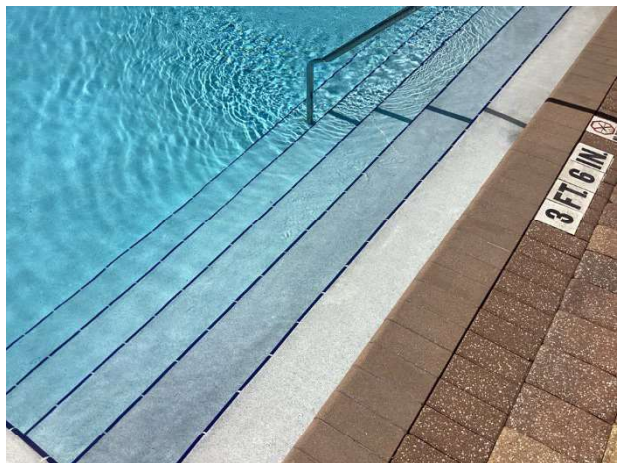
**Condition:** The Beachside pool plaster finish was in good overall condition. The Golfside pool plaster finish was in fair overall condition with isolated plaster chips evident

**Beachside pool plaster finish with tile perimeter**

**Beachside pool plaster finish**

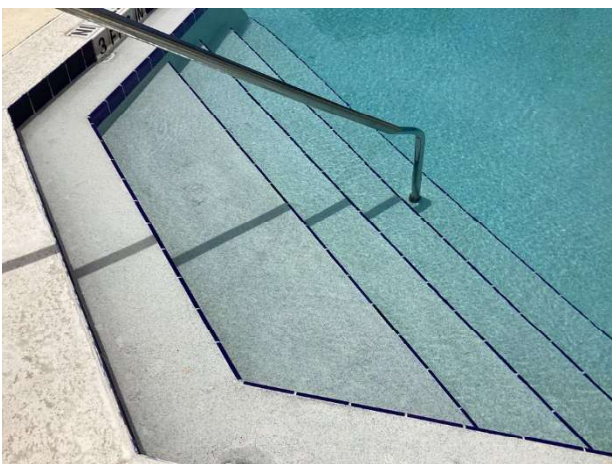
**Golfside pool plaster finish**

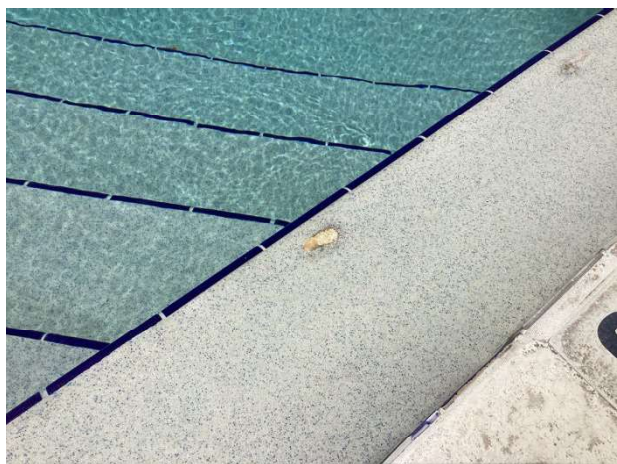
**Plaster chips**

- Removal and replacement of the plaster finish
- Partial replacements of the scuppers and coping as needed
- Replacement of tile
- Replacement of joint sealants as needed
- Concrete structure repairs as needed
